Manhole Inspection Summary

Manhole # S37EE_045MH

Insp Date: **3/23/07 8:59 AM**

Location Address: **702 MURA ST**

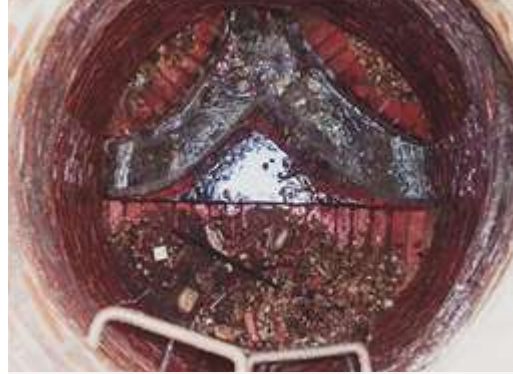
Top View

Evidence of surcharge - Bench debris.
Channel debris.

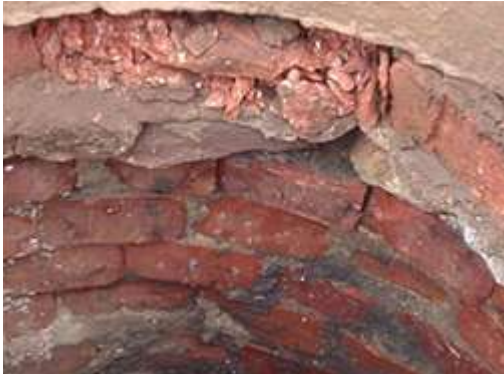
Defect

☒ **Leaks**

Condition: ☐ Sound ☐ Cracked ☐ Root Intrusion ☒ **Loose Brick** ☒ **Deteriorated**

Infiltration: ☐ None ☒ **Joint** ☐ Cracks ☒ **Mortar** ☐ Roots ☐ Wall

Frame leaks. Adjustment deterioration,
loose brick and infiltration.

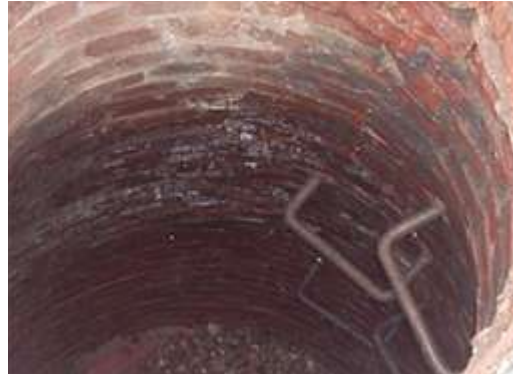
Defect

Infiltration: ☐ None ☐ Joint ☐ Cracks ☒ **Mortar** ☐ Roots ☒ **Wall**

Barrel infiltration. Evidence of surcharge -
Bench debris.

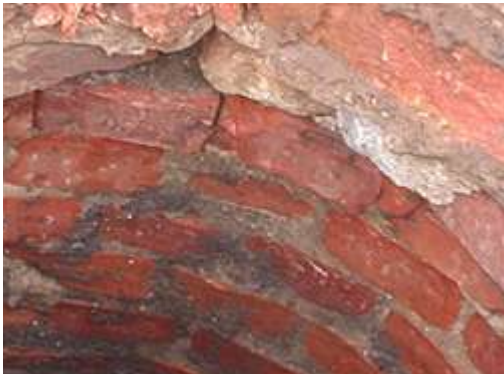
Defect

Condition: ☐ Sound ☐ Cracked ☐ Root Intrusion ☐ Loose Brick ☒ **Deteriorated**

Infiltration: ☐ None ☐ Joint ☐ Cracks ☒ **Mortar** ☐ Roots ☒ **Wall**

Corbel deterioration and infiltration.

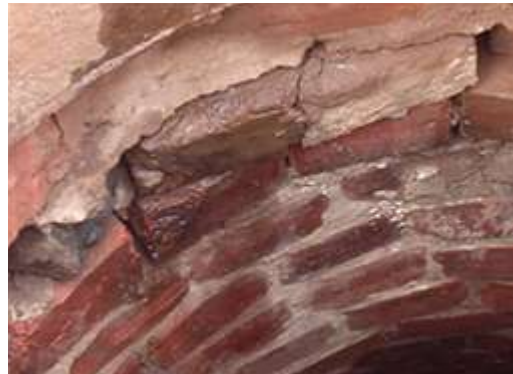
Defect

Frame leaks. Adjustment deterioration
and infiltration.

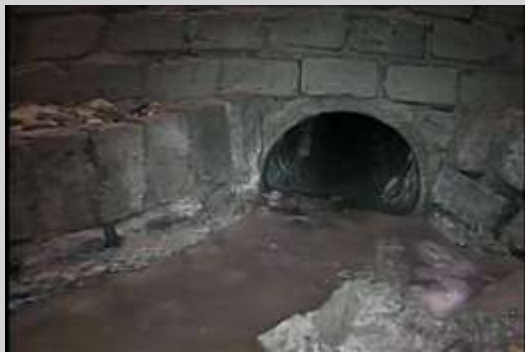
8 in. Circular Gravity Sewer Pipe Out @ 12 O'Clock

Deposits: ☐ None ☐ Mud ☐ Sludge ☒ **Debris** ☒ **Grease**

Silt Depth: **1** (in.) Deposits Extent: **Light**

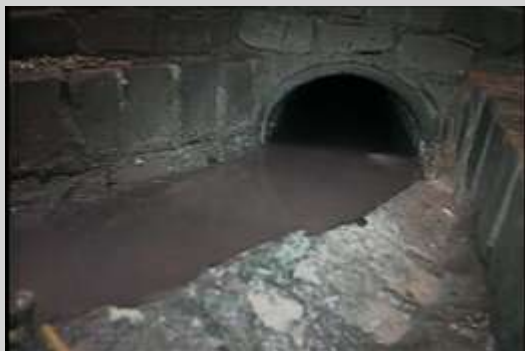
8 in. Circular Gravity Sewer Pipe In @ 3 O'Clock

Deposits: ☐ None ☐ Mud ☐ Sludge ☒ **Debris** ☒ **Grease**

Infiltration: **Evidence** Pipe Seal Cond: **Unknown**

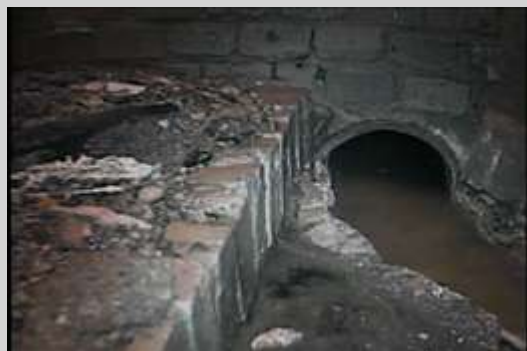
Pipe In @ 9 O'Clock

Channel deterioration.

Deposits: ☐ None ☐ Mud ☐ Sludge ☒ **Debris** ☒ **Grease**

Infiltration: **Evidence**
